Navajo Abandoned Uranium Mine Site Screen Report

Red Top AUM Site

Navajo AUM Eastern Region

May 2009

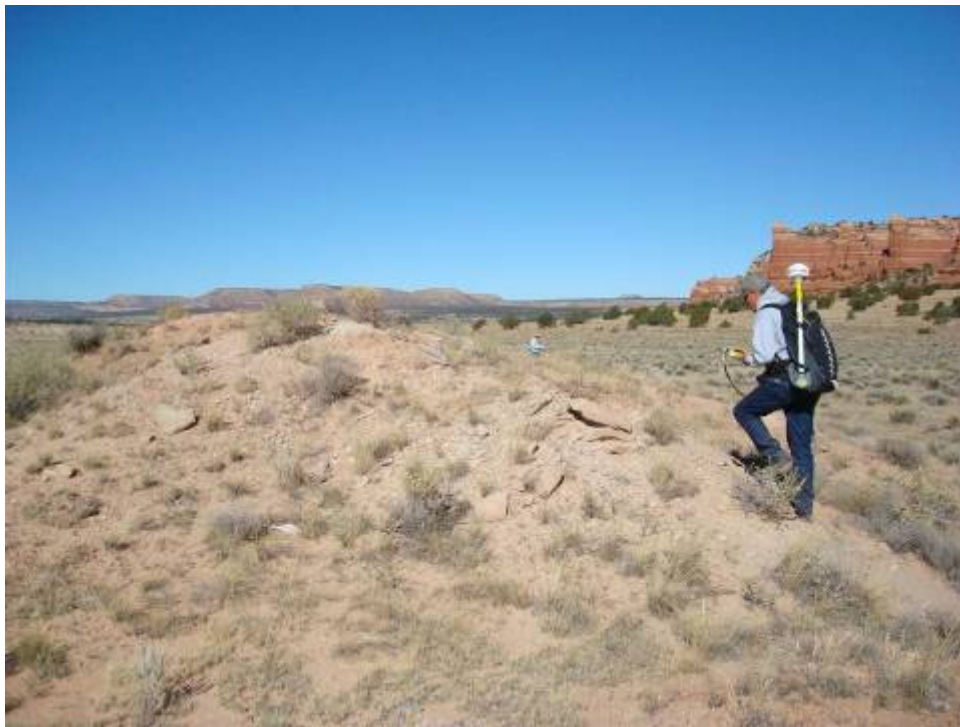
Photo 3. Red Top Mine site, waste rock pile

Reclamation status of the mine sites are currently unknown. No visible signs of reclamation were observed. A linear area appears to have experienced some subsidence. Waste Rock (soil) piles were observed. No adits or other mine features were observed during the site visit.

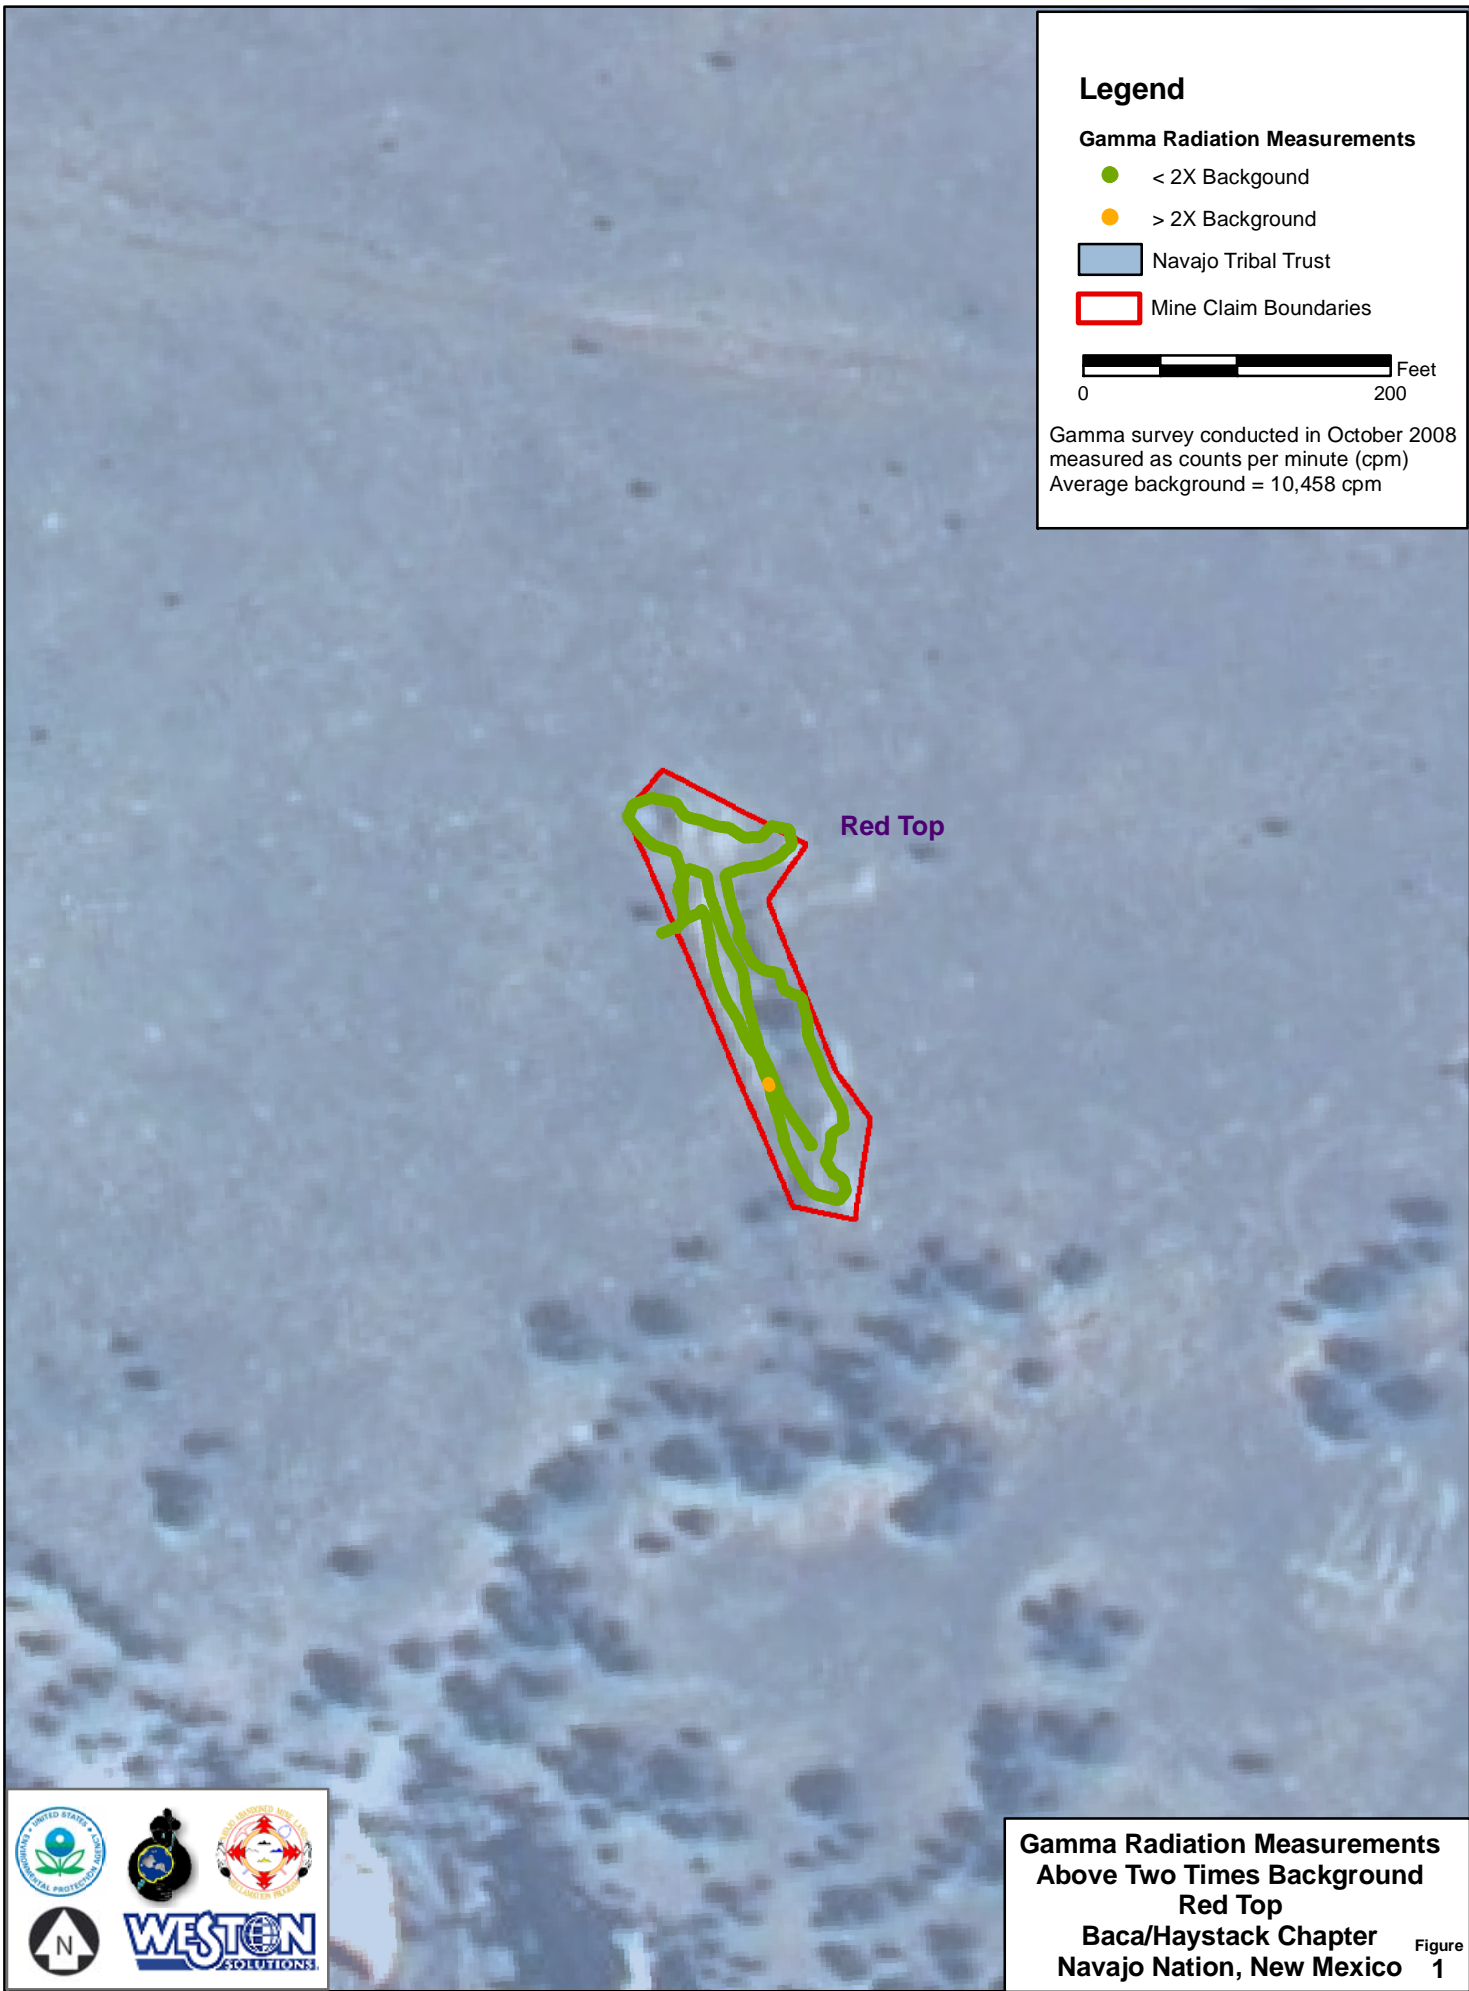
Figure
1

A total of 3,228 gamma radiation measurements were collected from mine sites, ranging from 6,197 cpm to 144,738 cpm. The measurements are represented in Figures 1 and 2.

Gamma survey conducted in October 2008
measured as counts per minute (cpm)
Average background = 10,458 cpm

**Gamma Radiation Measurements
Above Two Times Background
Red Top
Baca/Haystack Chapter
Navajo Nation, New Mexico**

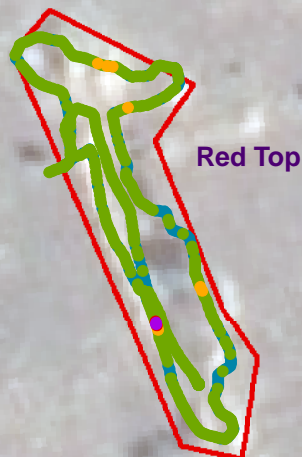
Figure
2

Gamma survey conducted in October 2008
measured as counts per minute

Gamma Radiation Measurements
